ALLIED
SURVEYORS
SCOTLAND

Single Survey

North Deskie
Lumsden
Huntly
AB54 4JR

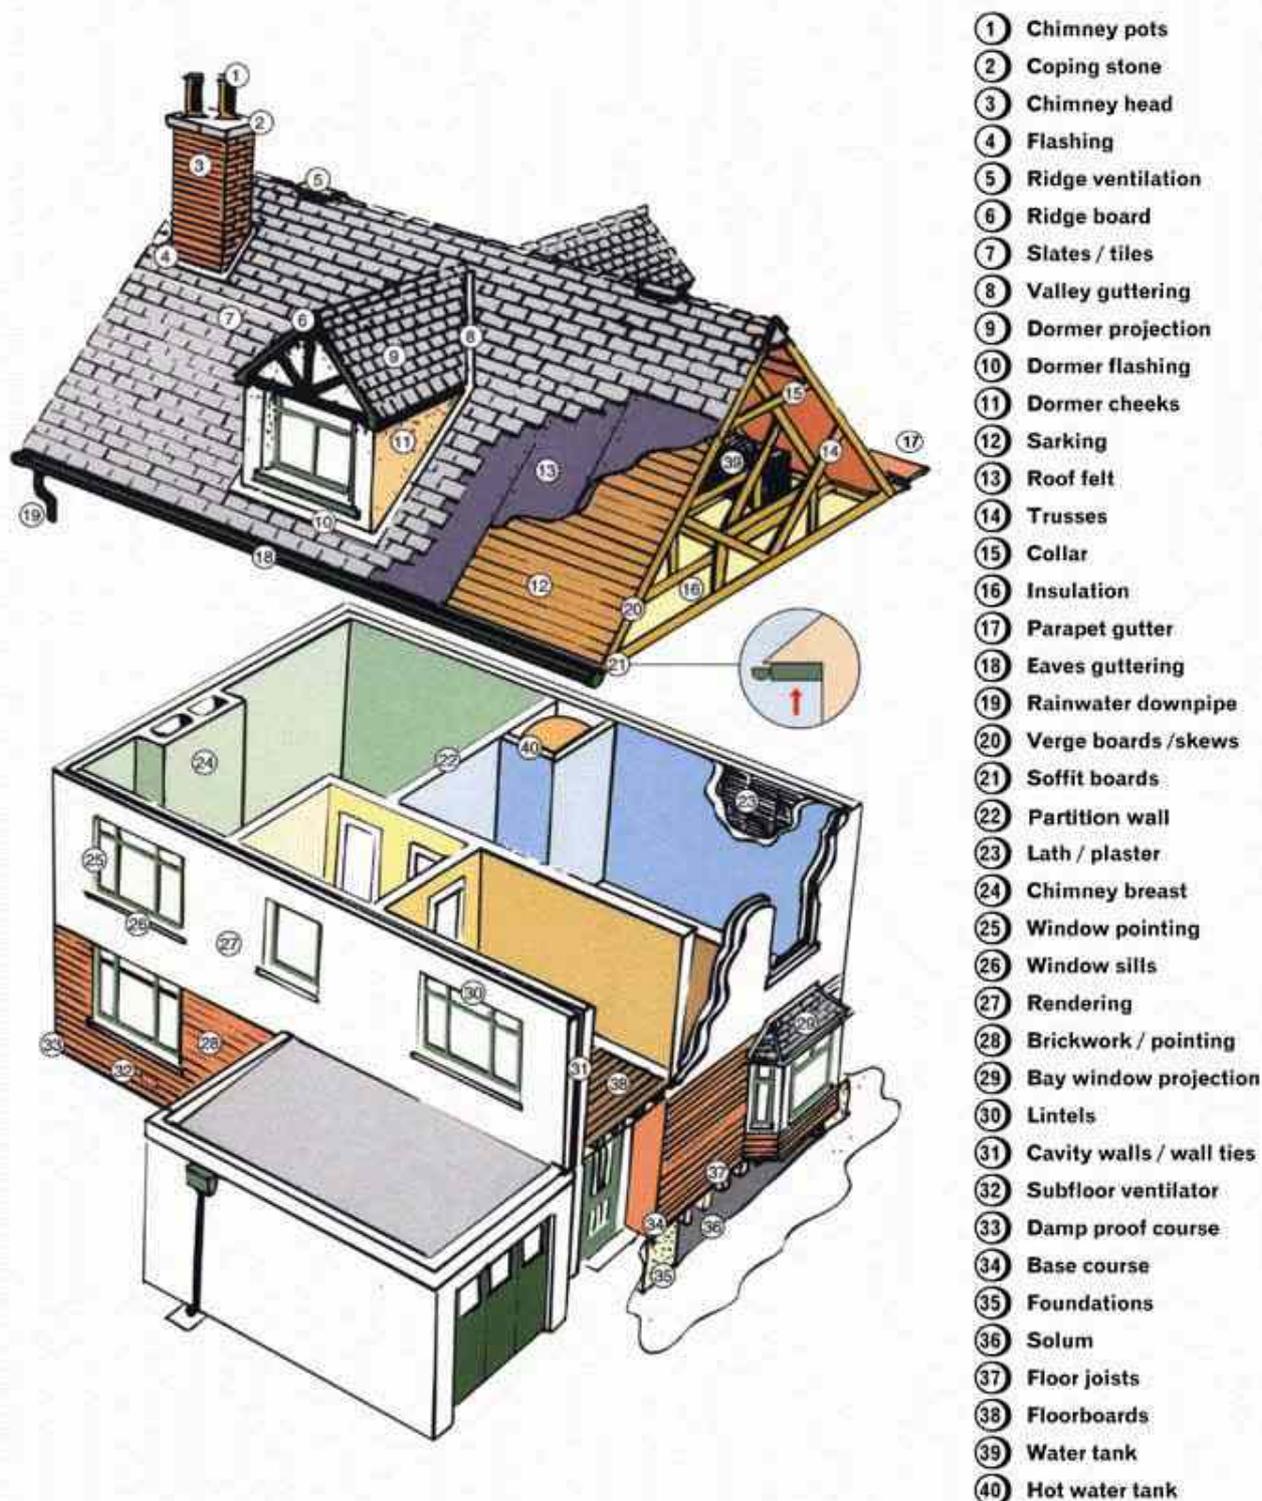
Sectional Diagram showing elements of a typical house

Reference may be made in this report to some or all of the above component parts of the property. This diagram may assist you in locating and understanding these items.
